## Brackenridge High School (HS) Environmental Notice – PAH Soils

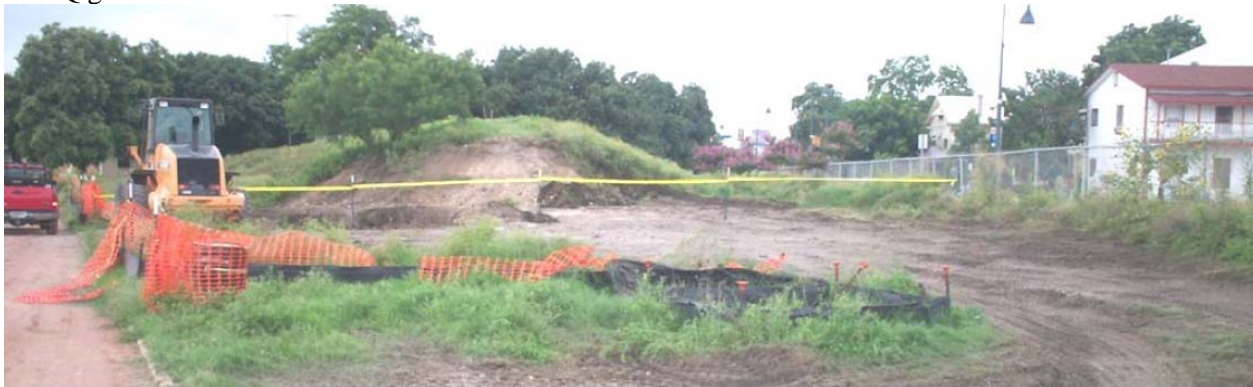
*The picture above shows the environmental contractor removing the “berm” soil while the picture below shows the foundation remnants from the former high school.*

In the summer of 2007 SAISD hired an environmental construction firm to remove the mound containing the PAH soil. The removal of the mound revealed the presence of concrete foundation structures from a former high school. The construction debris from the collapsed school is the probably source of the PAH contamination. All mound and subsurface construction debris was removed from the area (east of the track). The work was performed with the approval and under the oversight of the TCEQ. Approximately 10,000 cubic yards of soil and construction debris were removed.

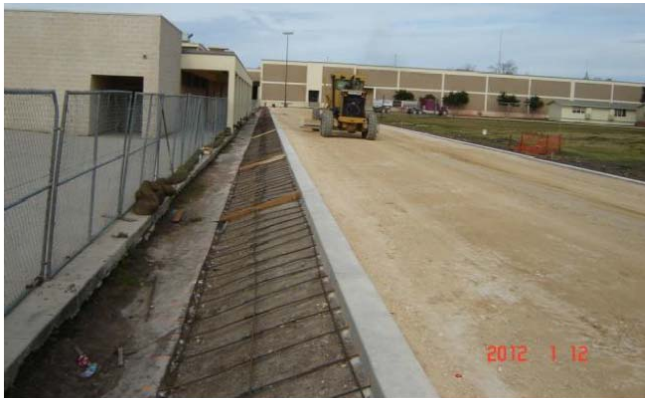
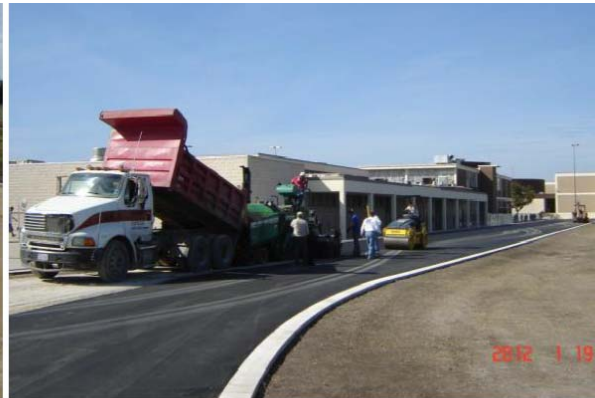
*Top views (taken on January 12 and 19, 2012) show compacted flex base and placement of 3" of asphalt.* In 2012 an all-weather track was installed providing a higher degree of physical control (from the remaining PAH soils) than the (previous) cider track. On September 30, 2013 Mr. Craig Tribbley, P.G. with STC Environmental Services Inc. of San Antonio, Texas confirmed that the physical control remains in place and is in good condition.

In 2012 the cider track was replaced with an all-weather track. The track improved site drainage and provided a durable protective layer over a substantial portion of the PCLE zone. The engineered track surface included: a ½ inch rubber running surface; 3 inches of asphalt; and 9 inches of compacted base.

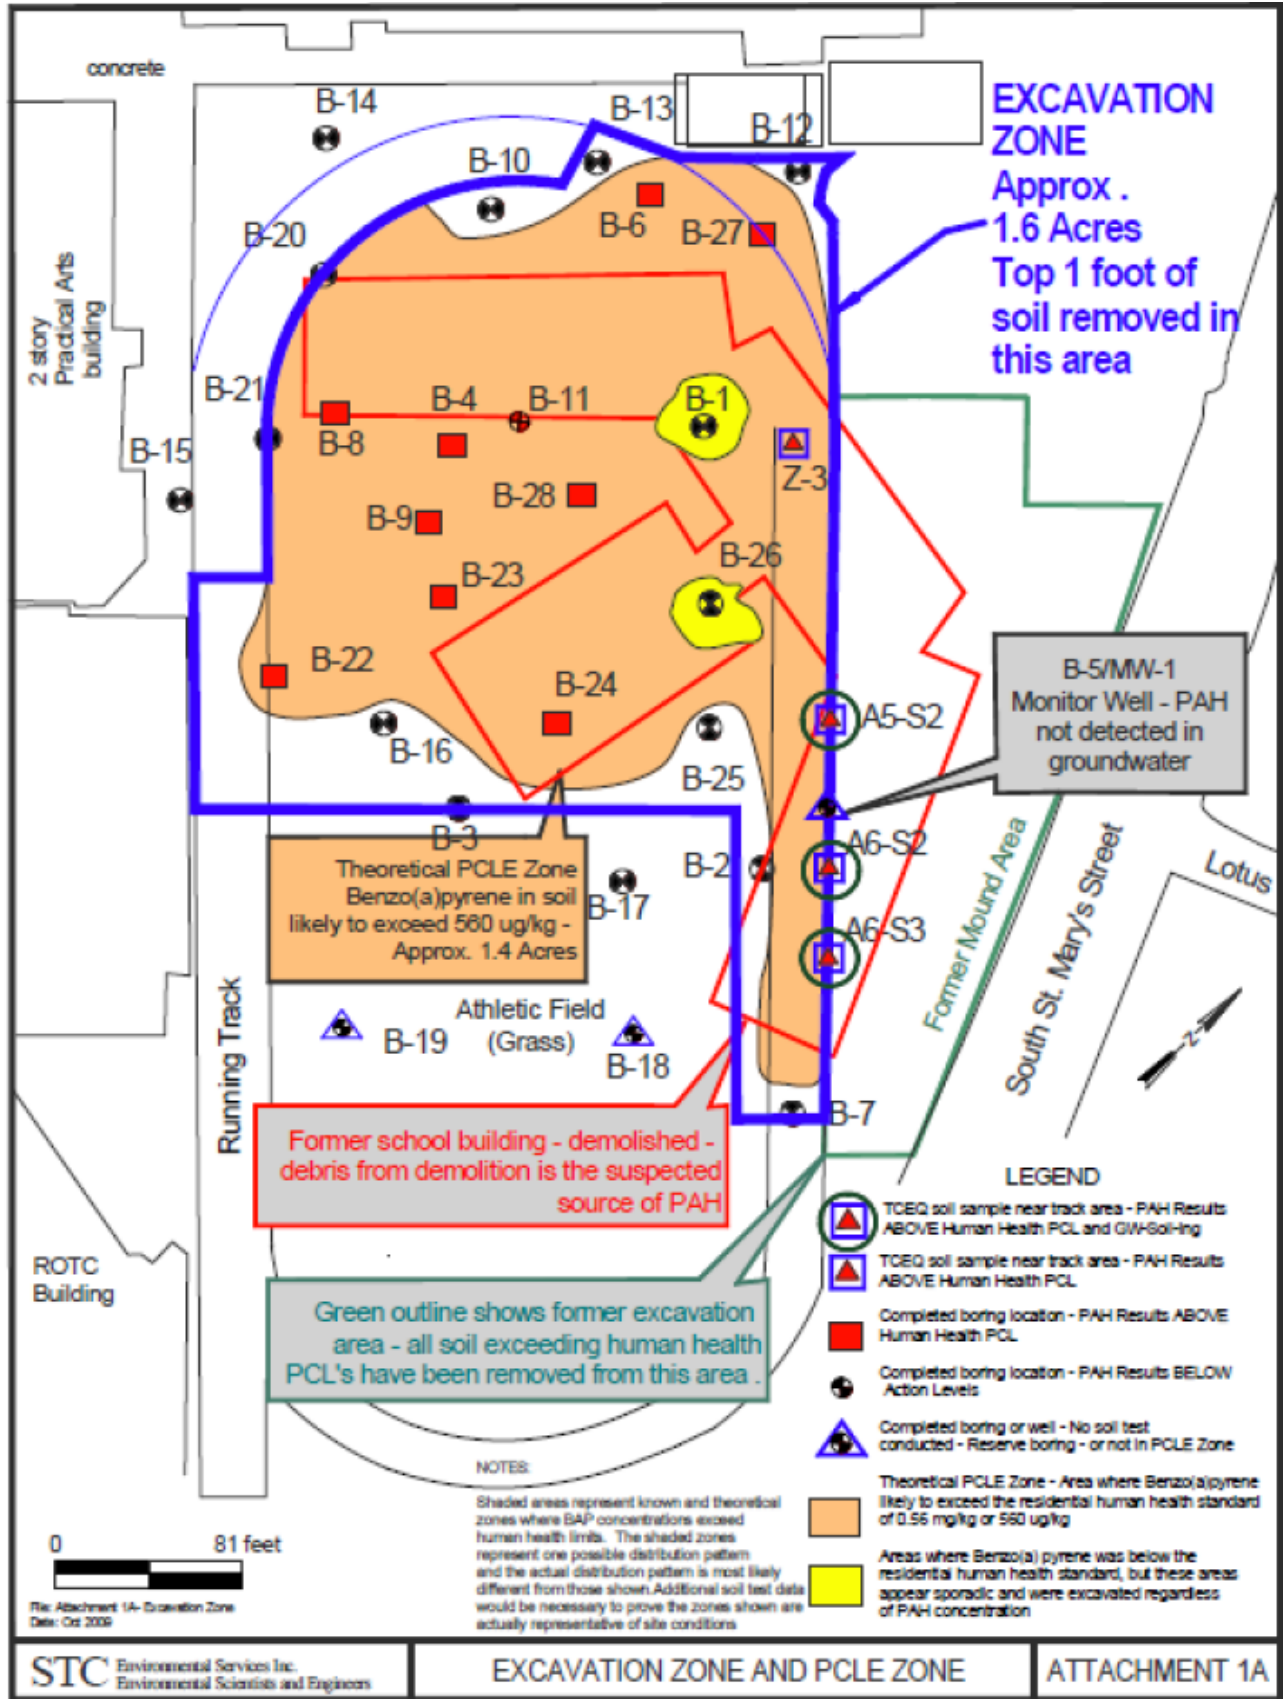
SAISD submitted, and TCEQ approved a response action plan (RAP) to address the remaining the area affected by the PAH contaminated construction debris. The “Excavation Zone and PCLE Zone” as shown in the Response Action Completion Report (RACR) for Brackenridge HS is provided on page 3 of this notice. In the summer of 2009, SAISD removed 12-inches of top soil and track material from the

1. There is PAH soil under part of the track and field at Brackenridge HS.
2. A protective layer (physical control) protects students, staff and the general public from any ill effects of these PAH containing soils.
3. The effectiveness of physical control is verified every three years by a licensed professional geologist.
4. The physical control must not be damaged or modified. This would include any drilling or excavation in excess of 12 inches below the area demarcated in the diagram noted below.

"protective concentration level exceedence zone", placed a geotech fabric on the excavation; and installed the one-foot physical barrier of clean soil and track material over the fabric. 3,300 cubic yards of soil was removed from the exceedence zone and disposed of as Class II non-hazardous waste.
